Westmoreland Coal Company

MAIN SUBSTATION CIRCUIT BREAKER FAILURE

SHEERNESS MINE
WESTMORELAND COAL

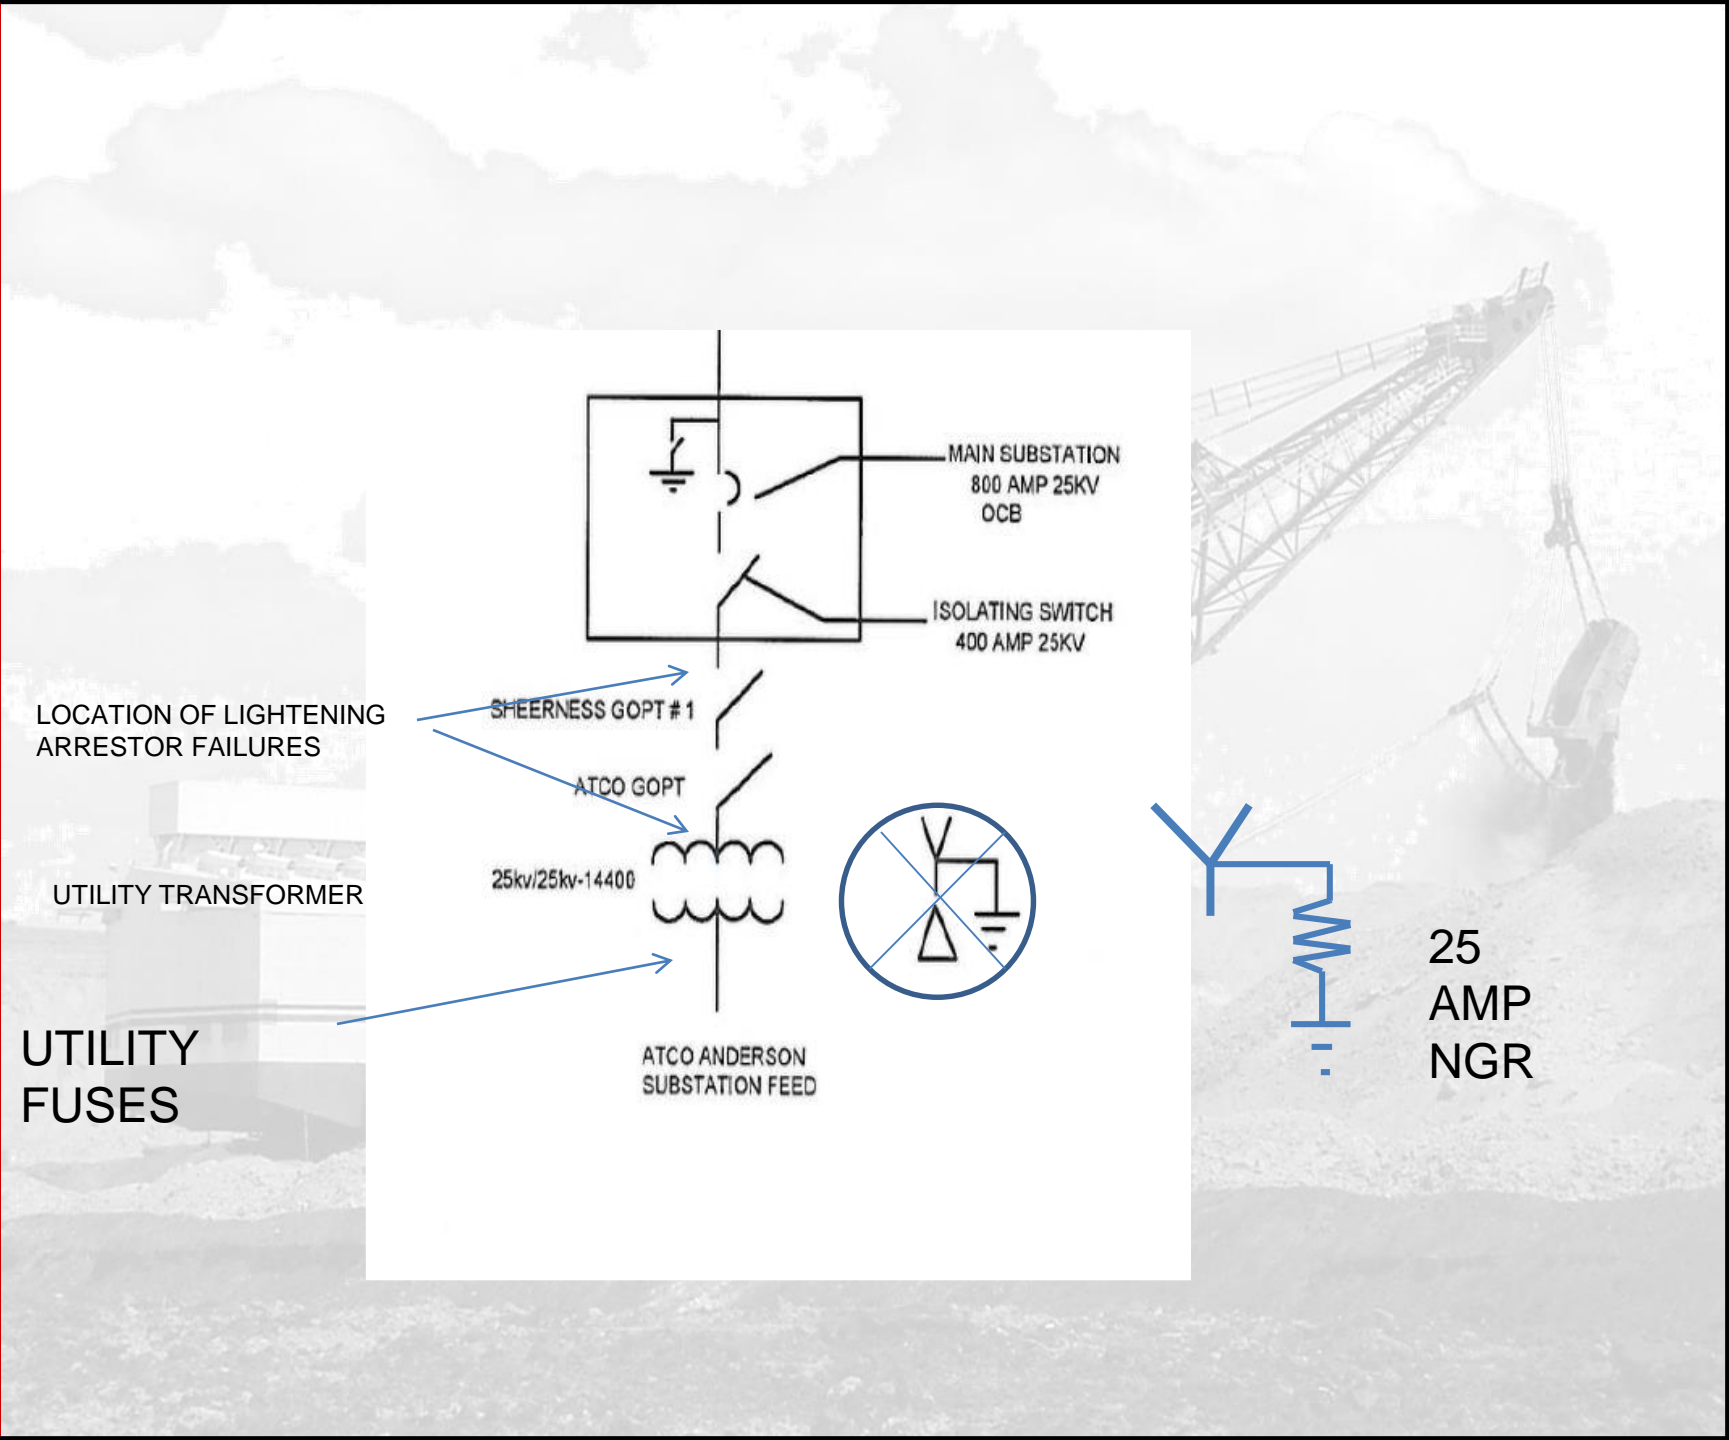
LOCATION OF LIGHTENING ARRESTOR FAILURES

UTILITY TRANSFORMER

UTILITY FUSES

- WORK ORDERS SHOW DIFFERENT STORY
 - LIGHTENING ARRESETOR FAILURES BETWEEN THE UTILITY TRANSFORMER AND OUR SUBSTATION,
 - WHEN INSPECTED IN THE SHOP OUR ARRESTORS WERE FOUND TO BE RATED AT 21 KV
 - THE THOUGHT NOW IS THAT PHASE TO PHASE 25KV WAS ON THESE ARRESTORS. THIS WOULD INDICATE AN UNCLEARED GROUND FAULT

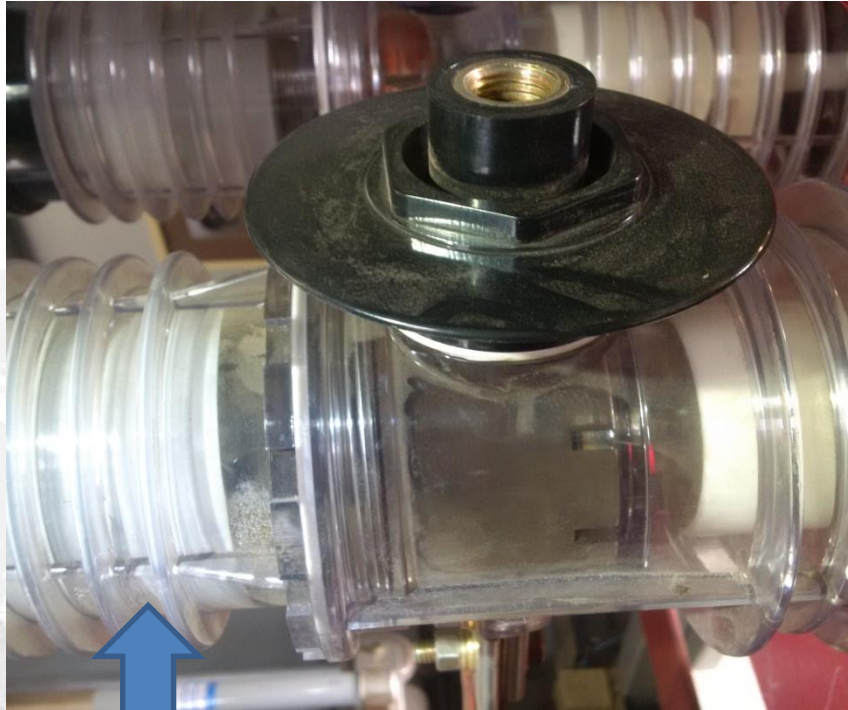
B PHASE LH-FAILED GOOD PHASE RH

- IT IS UNCLEAR WHAT THE RESULT WOULD HAVE BEEN IF THE FAILED CB POLE HAD NOT BEEN THE ONE WE WERE GROUNDING FOR THE TEST
 - WE COULD NOT SEE EVIDENCE OF ISSUES FROM THE SERVICE AISLE OF THE SWITCH HOUSE
 - WE ISOLATED AND CHECKED INSIDE. WE FOUND VISIBLE EVIDENCE OF FAILURE IN B PHASE

METAL SPRAY

DISCOLORED, DARK

- CB SHIPPED TO DELTA FOR INITIAL EVALUATION, REPLACEMENT SHIPPED
- CB NOW GO TO TAVRIDA FACILITY IN SWITZERLAND FOR MORE DETAILED ANALYSIS INCLUDING COMPONENT TRACKING
- SHEERNESS & PAINTEARTH MINES HAVE IMPLEMENTED HV INDICATORS ON LOAD AND LINE SIDE OF CB

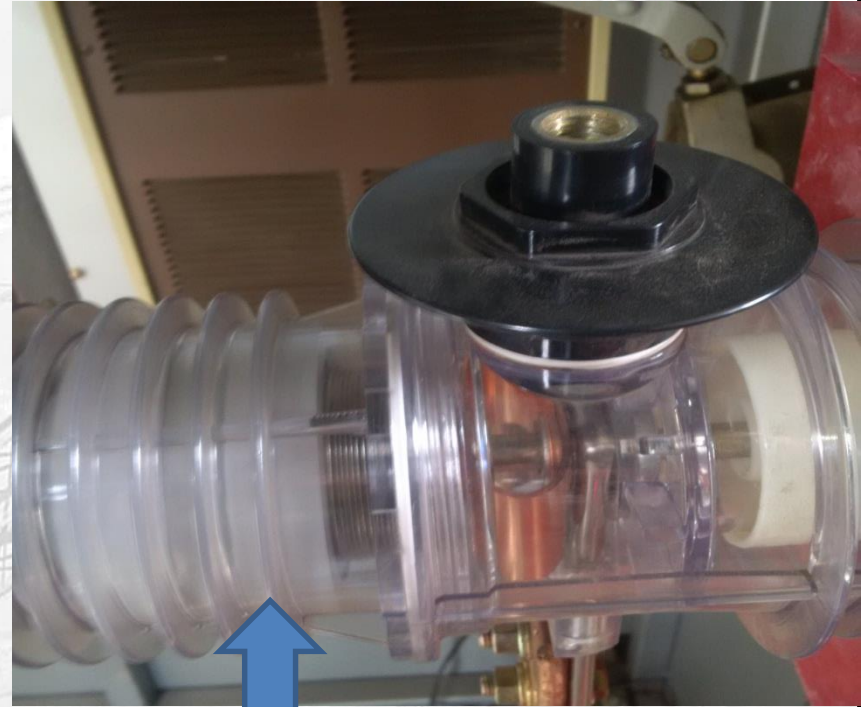
AREA CLEAR

CLEAR CAN SEE
COMPONENTS
