Westmoreland Coal Company

MAIN SUBSTATION CIRCUIT BREAKER FAILURE

SHEERNESS MINE
WESTMORELAND COAL

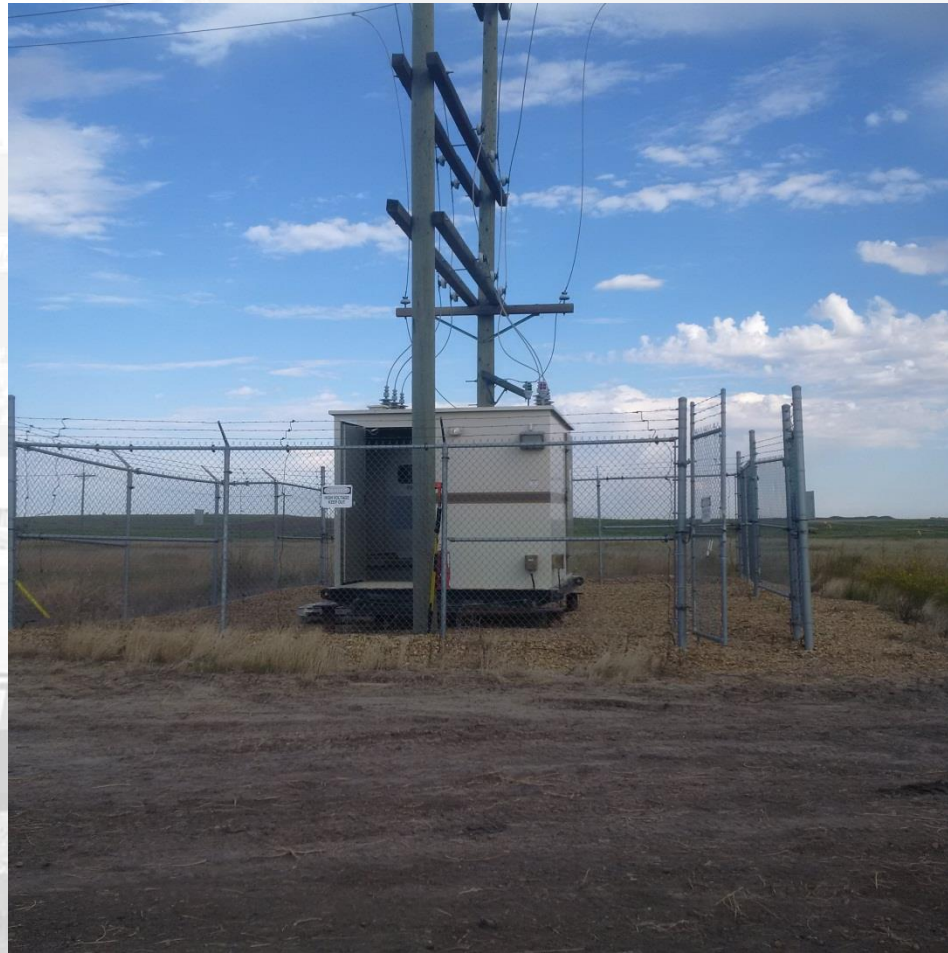
MAIN SUBSTATION SHEERNESS

- THE MAIN SUBSTATION CIRCUIT BREAKER FAILED WITHOUT INDICATION AND WAS OPERATED FOR AN UNKNOWN PERIOD OF TIME WITH THE B PHASE POLE 'STUCK' CLOSED. WAS ONLY DETECTED IN THE FOLLOW-UP TO POTENTIAL GROUND FAULT
 - PROTECTION FAILURE
 - THE PERSONNEL DANGER OF HAVING 1 PHASE ENERGIZED AFTER THE CB 'OPENS' IS HUGE. WITH 2 PHASES OPEN THE LITES GO OUT AND EVERYTHING APPEARS SAFE. POWERLINE STRIKES WOULD BE A MAJOR ISSUE

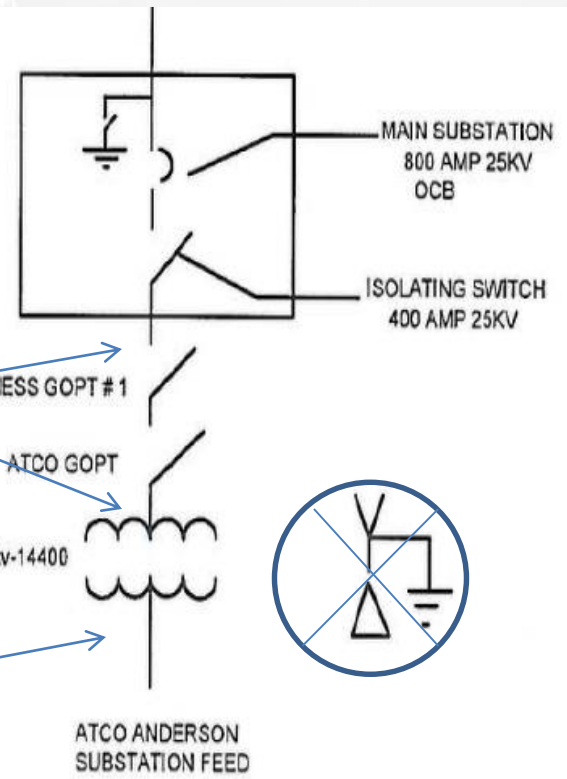
LOCATION OF LIGHTENING ARRESTOR FAILURES

- WORK ORDERS SHOW DIFFERENT STORY
 - LIGHTENING ARRESETOR FAILURES BETWEEN THE UTILITY TRANSFORMER AND OUR SUBSTATION,
 - WHEN INSPECTED IN THE SHOP OUR ARRESTORS WERE FOUND TO BE RATED AT 21 KV
 - THE THOUGHT NOW IS THAT PHASE TO PHASE 25KV WAS ON THESE ARRESTORS. THIS WOULD INDICATE AN UNCLEARED GROUND FAULT
